WAIKATO CARBONISATION PLANT – INVESTIGATING A HISTORICAL LEGACY

Glen Nicholson (Tonkin & Taylor Ltd, gnicholson@tonkin.co.nz, 07 571 3570)

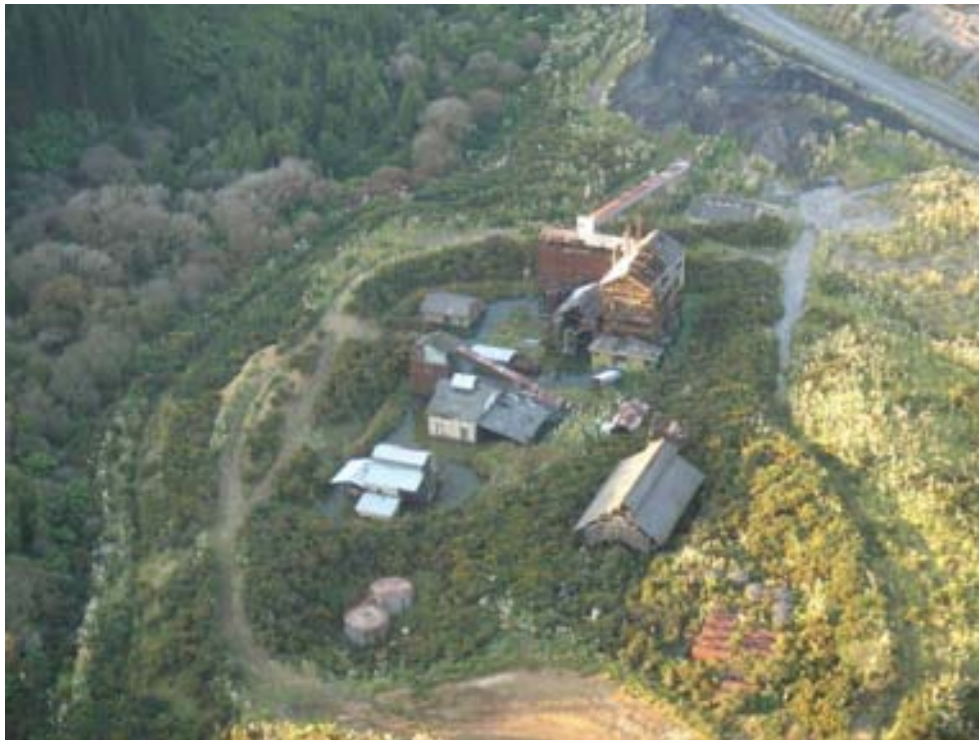
Photo 1: Waikato Carbonisation Plant (April 2007) prior to dewatering

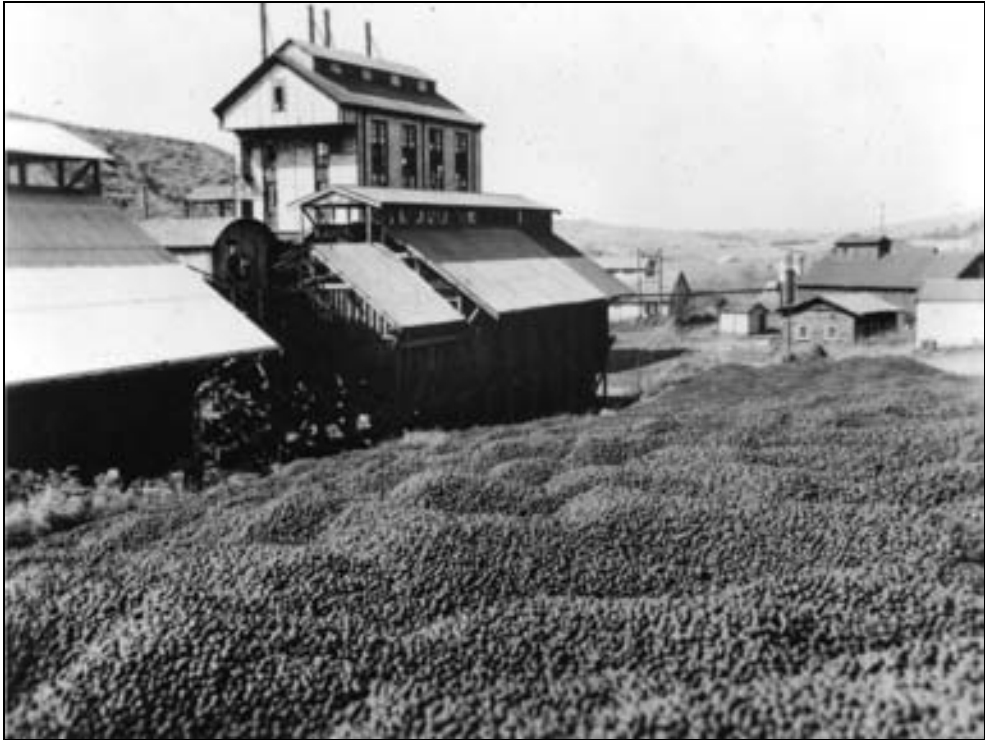
The historical significance of the site is recognised by the Historic Places Trust (HPT) as it has identified the Lurgi retort building and screening plant as Category 1 buildings, and has classified the whole site as a Historical Area. The WCP was the first Lurgi (heating in the absence of air) plant to be constructed in the Southern Hemisphere. (Photo 2)

Photo 2: WCP showing the Lurgi Retort building, screening plant. Note the stored carbonettes in the foreground.

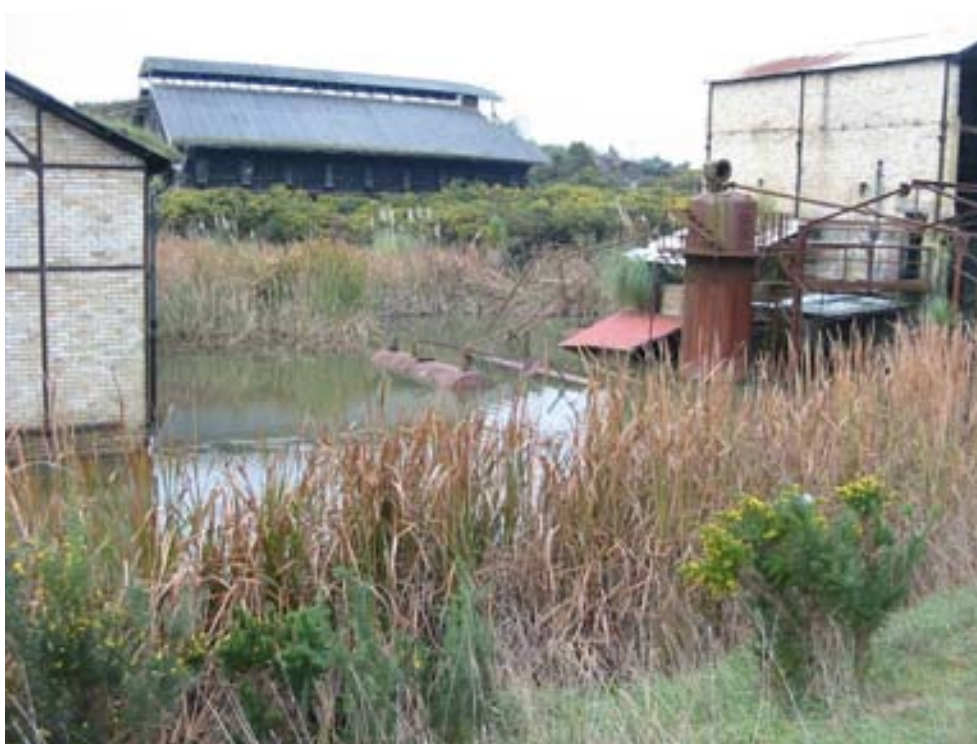
The work resulted in the formation of two banded areas, one containing the majority of the WCP buildings and the other containing the two steel tar storage tanks (Figure 1). A 150 mm diameter pipe linking the two areas and a 300 mm diameter pipe discharging to the Awaroa Stream were inserted in the bunds. The construction of the bund and key together with the location of the discharge pipe to the Awaroa Stream has resulted in around 2 to 3 metres of ponded water around the existing buildings and steel tar tanks (Photo 3).

Photo 3: Flooded site looking towards the Briquette Plant and above ground storage tanks

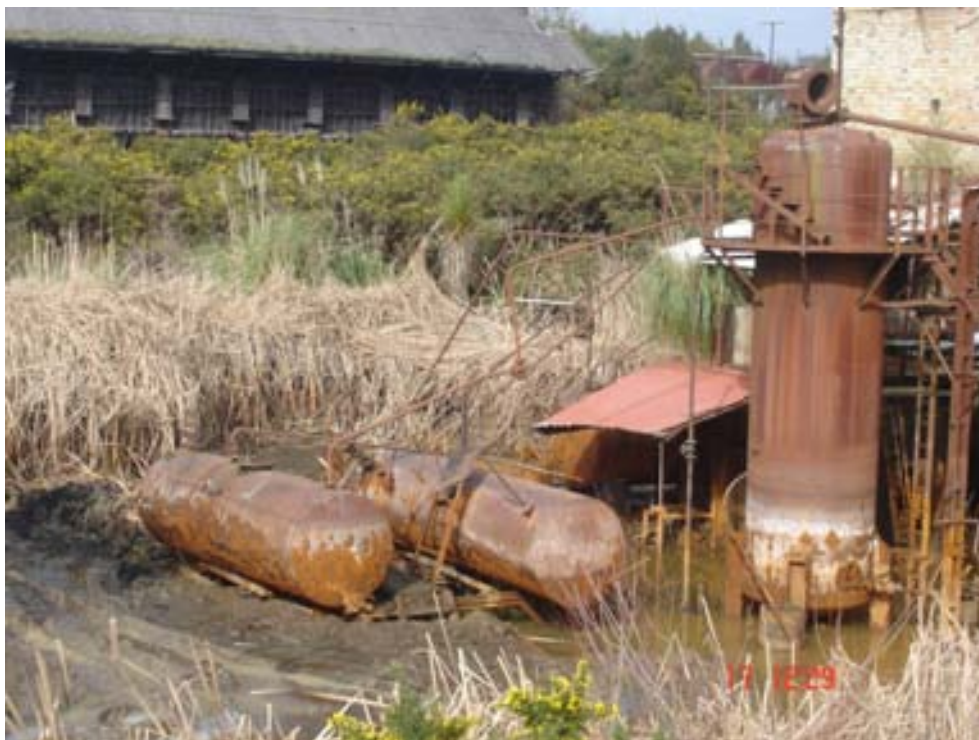
The site investigation and audit initially required the dewatering of the site. This involved the draining the site, and disposing of the water by irrigation to land. Up to 12,000 cubic metres of water was pumped from the site to provide access to the site and buildings (Photo 4).

Photo 4: WCP following dewatering, showing existing above ground storage tanks containing residual coal tar

The site audit found a total of 335 cubic metres of coal tar stored in the above ground storage tanks. The storage tanks were found to be in a poor condition, with rust and corrosion evident around the water line and valves (Photo 4). Other potential contaminants include Polychlorinated biphenyls PCBs and asbestos. Asbestos roofing material is present on most of the buildings and some is present as lagging, around heating pipes. PCBs are most likely to be associated with cooling and insulating fluid in sites transformers and in capacitors that are identified at the site.

- The removal and offsite disposal of the stored coal tar. A discharge of contaminants to stormwater within the bunded area is occurring. Which is visually evident by a hydrocarbon sheen on the water surface. It is possible that this could be leaking from the stored coal tar. The tanks are in a poor condition and a mass release of product could occur, resulting in a significant discharge to the Awaroa Stream.
